Water Supply and Drainage at Machu Picchu

Jeff L. Brown

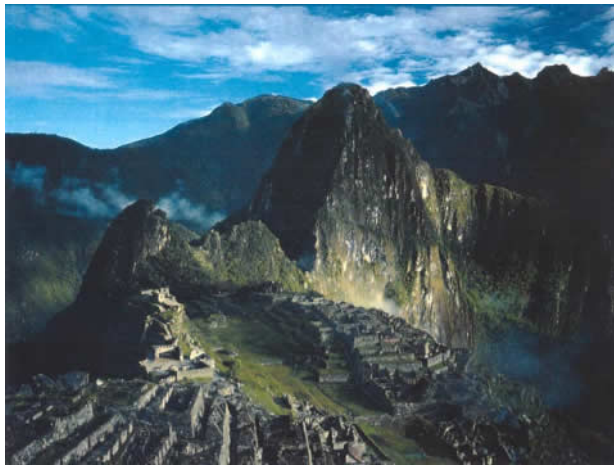
Photograph 1. Machu Picchu's unique geography presented Inca engineers with a number of challenges

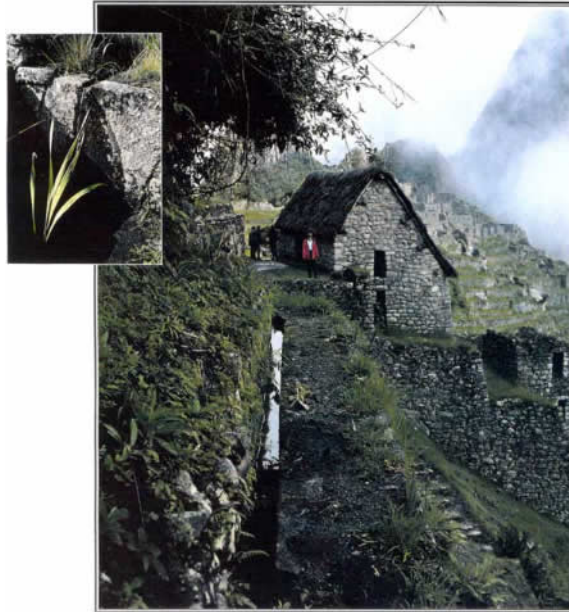
Photograph 2. The Inca supply canal flowed gently into Machu Picchu at an engineered grade on a carefully built terraced right-of-way.

The Inca built the water supply canal on a relatively steady grade, depending on gravity flow to carry the water from the spring to the city center. They used cut stones to construct a channel that typically ranged from 10 to 16 cm deep and 10 to 12 cm wide at the bottom. Wright's team concluded that the nominal design capacity of the channel was about 300 L/min, or more than twice the typical 25 to 150 L/min yield of the primary spring (see Photograph 2).

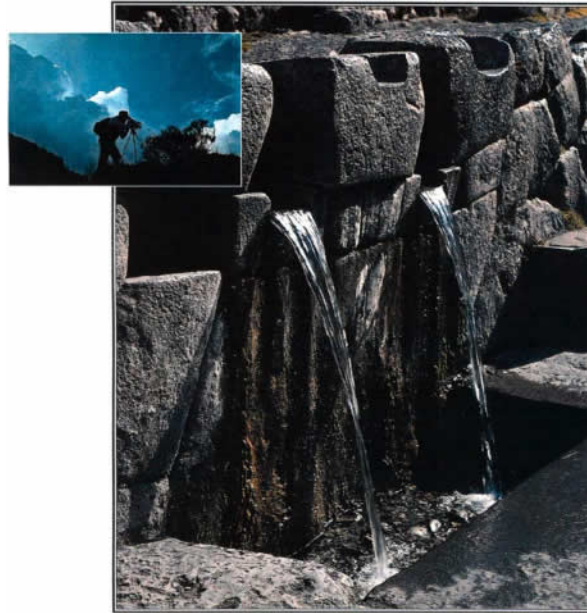
Photograph 3. The water supply canal ends in a series of 16 semiprivate fountains.

The canal descends the mountain slope, enters the city walls, passes through the agricultural sector, then crosses the inner wall into the urban sector, where it feeds a series of 16 fountains known as the stairway of fountains. The fountains are publicly accessible and partially enclosed by walls that are typically about 1.2 m high, except for the lowest fountain, which is a private fountain for the Temple of the Condor and has higher walls. At the head of each fountain, a cut stone conduit carries the water to a rectangular spout, which is shaped to create a jet of water suitable for filling aryballo—a typical Inca clay water jug. The water collects in a stone basin in the floor of the fountain, then enters a circular drain that delivers it to the approach channel for the next fountain.

Wright and his team studied the fountains in detail, conducting hydraulic flow tests and measuring the channels and outlets (see Photograph 3). They concluded that the Inca designed the fountains to operate optimally with a flow of about 25 L/min, but the fountains would operate with flows as low as 10 L/min and could handle a maximum flow of 100 L/min. The team found water control points at two places along the canal where excess water would have spilled onto the agricultural terraces or into Machu Picchu's main drain before reaching the fountains.
